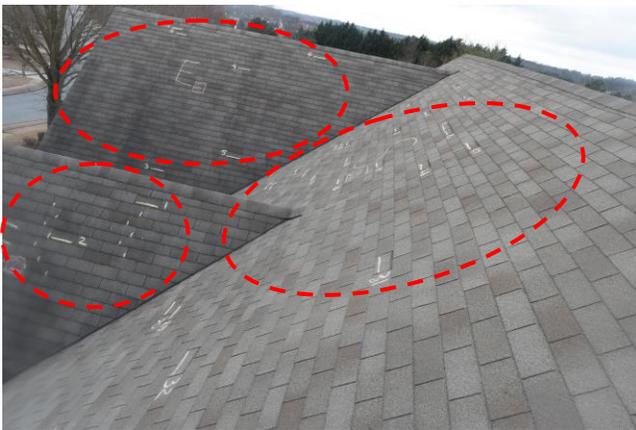
**Figure 1: DAMAGE IS PRESENT ON ALL SLOPES.**

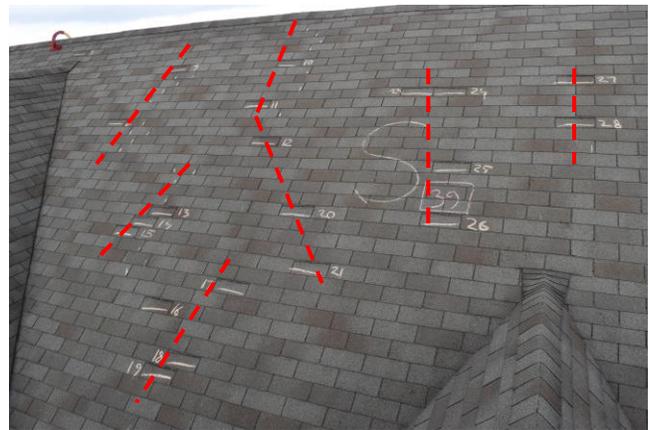
**Figure 2: DAMAGE IS CONCENTRATED ON FIELDS & FOLLOWS A PATTERN.**

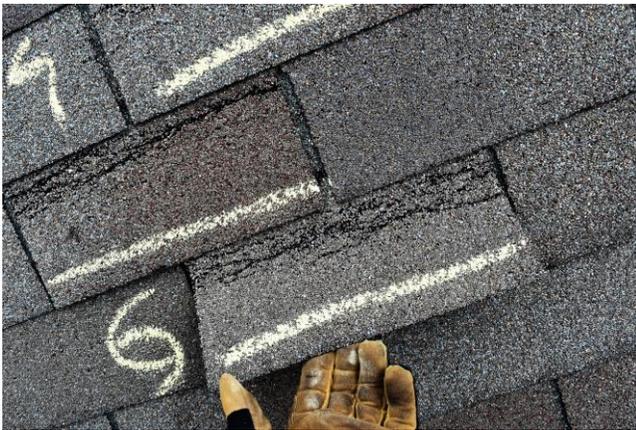
**Figure 3: SHINGLE TABS WITH DOUBLE CREASES.**

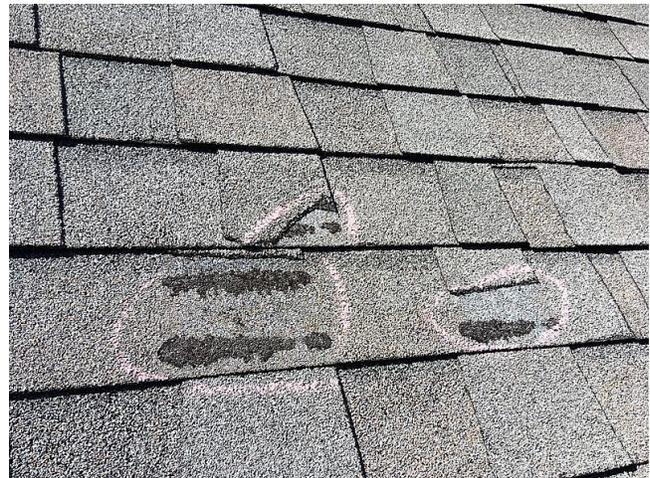
**Figure 4: TOTALLY, PARTIALLY AND DIAGONALLY TORN SHINGLE TABS.**

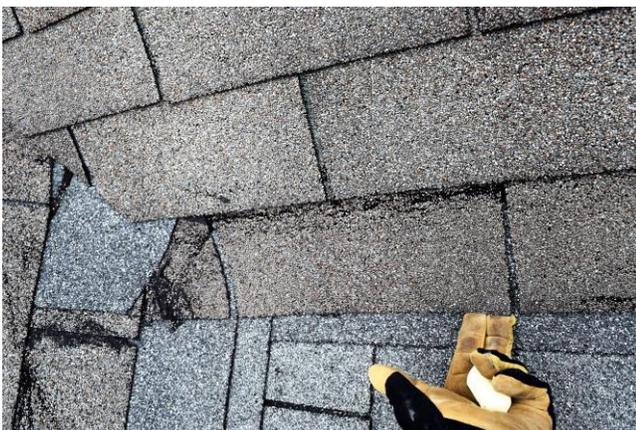
**Figure 5: CREASED SHINGLES THAT GOT REPAIRED ARE NOT SUSCEPTIBLE TO WIND DAMAGE.**

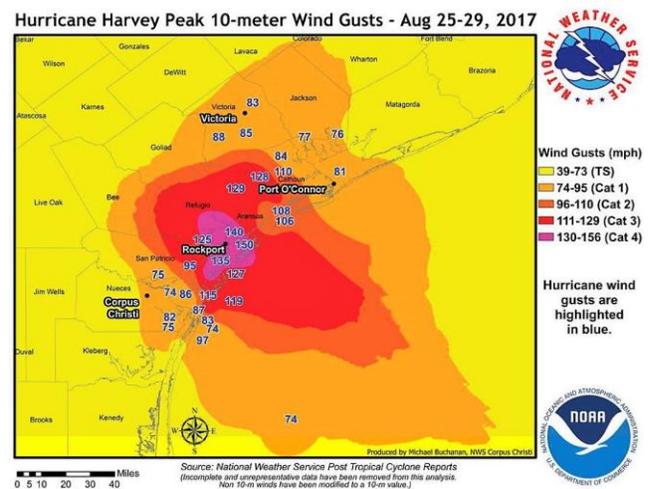
**Figure 6: REPORTED WIND SPEEDS AT THE SITE SHOULD CORRESPOND WITH FOUND DAMAGE.**
